High performance spray foam insulation for grade 2 listed barn restoration

Old Mill Barn is a Grade 2 listed building, situated close to the River Rib in the conservation area of Standon Village. The owners of the building were granted permission to convert the L-shaped single and two-story structure into a two-bed home and engaged Hertfordshire based conservation contractors, Datum Point Construction to undertake the work.

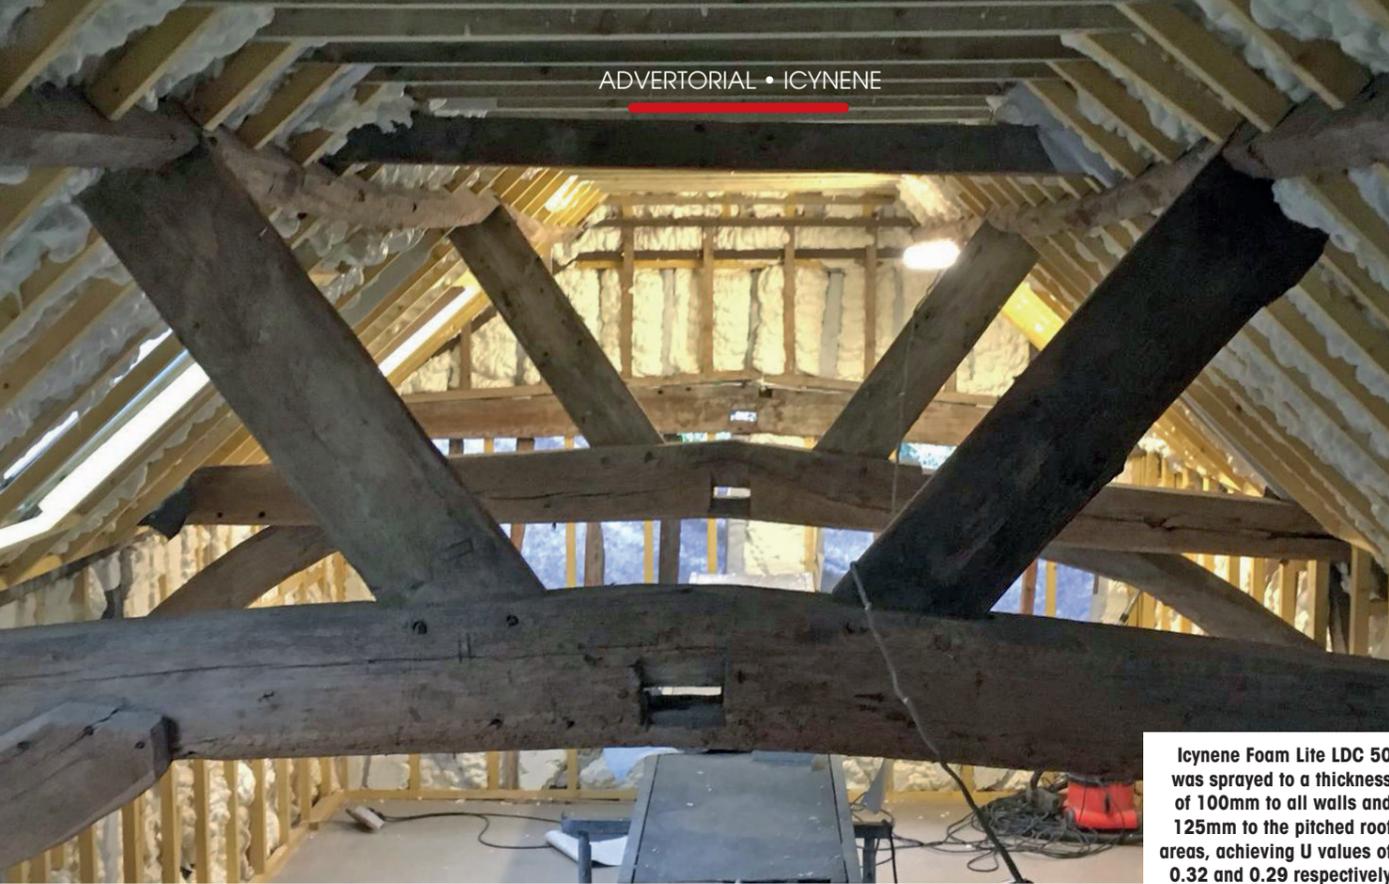
Icynene Foam Lite LDC 50 was sprayed to a thickness of 100mm to all walls and 125mm to the pitched roof areas, achieving U values of 0.32 and 0.29 respectively

Insulation sub-contractor, Foam Insulations Ltd, applied Icynene's Foam Lite LDC 50 to a thickness of 100mm to all walls and 125mm to the pitched roof areas, achieving U values of 0.32 and 0.29 respectively.

To satisfy the Conservation Officer requirements, Datum Point Construction stapled a physical breather membrane to the inside of the timber cladding and original posts so that, if any repairs are need to the timber cladding or frame at a later date, it would be easier to separate the from the foam to undertake any required repairs or replacements.

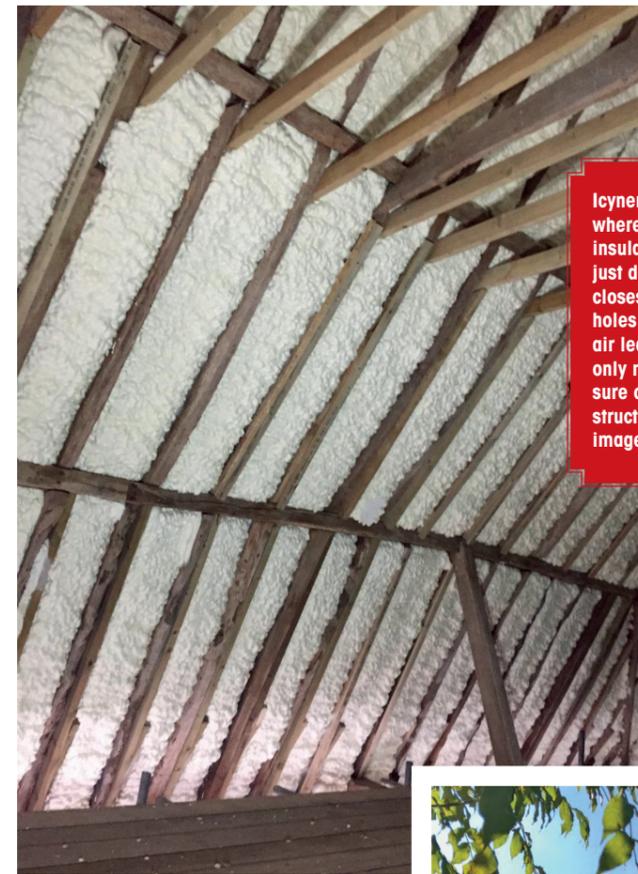
Icynene performs where traditional insulation materials just don't work. It closes off gaps and holes and reduces air leakage yet puts only minimal pressure on the building structure. [Library image]

Icynene Foam Lite is a spray applied system that expands instantly on application. It's specifically designed to get into difficult to fill areas where traditional insulation materials just don't work. It closes off gaps and holes, reducing air leakage, but because it has a soft, yielding texture, it puts only minimal pressure on the building structure.

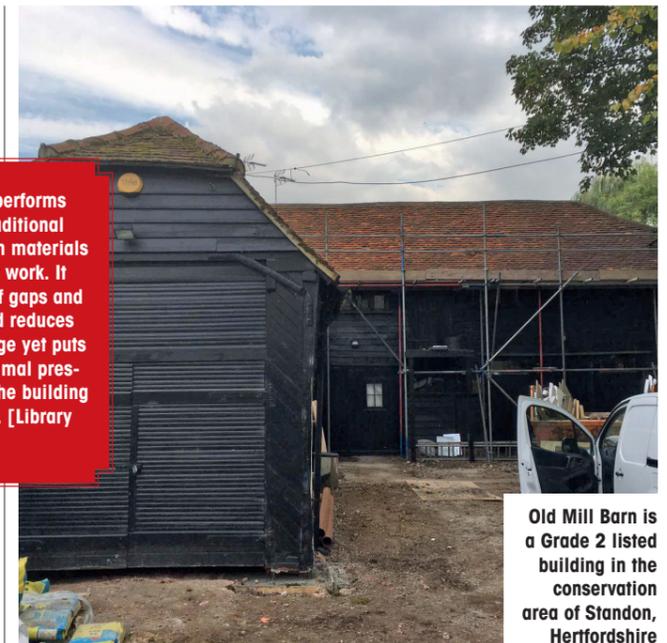
Old Mill Barn is a Grade 2 listed building in the conservation area of Standon, Hertfordshire

The barn comprises a traditional internal frame of rough-hewn timbers with an external skin of dark painted weatherboard, set on a low brick plinth. Roofs are pitched, with clay plain tiles and half

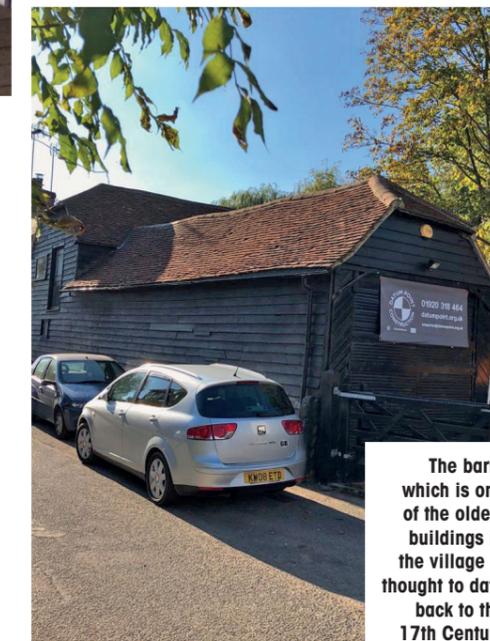
The barn, which is one of the oldest buildings in the village is thought to date back to the 17th Century

The barn, which is one of the oldest buildings in the village and thought to date back to the 17th Century, had up until recently, been used as a storage facility. Much of the original timber frame and external horizontal timber boarded exterior were still in place and in relatively good condition.
